# Memorandum

**Date:** May 25, 2021  
**File:** 02-PLU-70-85.7/89.35  
0218000068  
Beckwourth Cap M

**Subject: Geotechnical Memo- Pavement Cracking - Assessment and Recommendations**

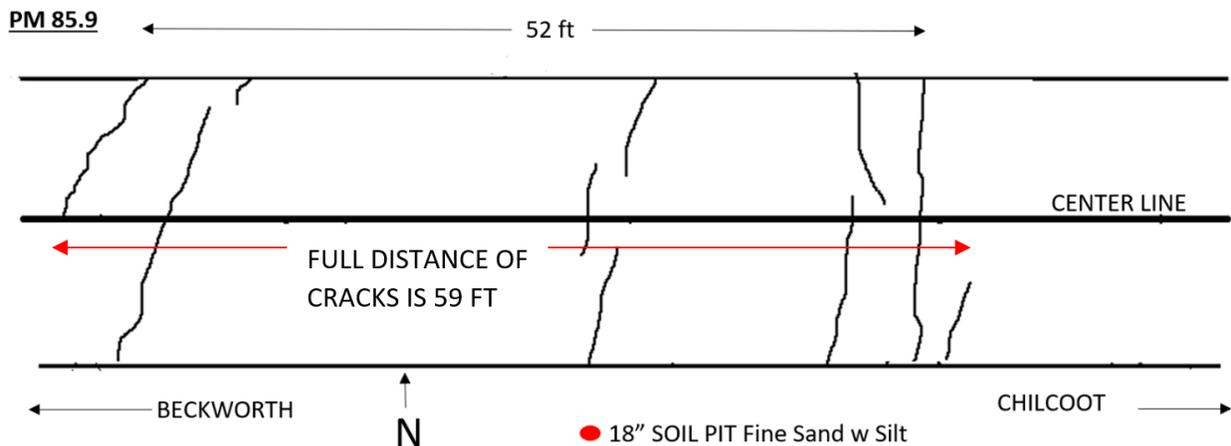
**Figure 2.** Crack Layout at Site 1 (PM 85.9)

The cracking at all three sites displays some degree of extension, with the cumulative extension at any one site estimated (based on measurements) to be close to 4 inches. Some cracks show vertical offset and little extension, some show no vertical offset and little to some extension, and still others show vertical offset AND some extension. Some individual cracks demonstrated up to about 1.5 inches of extension and 1 inch of vertical subsidence. These quantities are an indication of how much extension or down-dropping has occurred since the most recent patching effort by maintenance. Pavement areas between cracks show various types of movement, primarily tilting and down-dropping. This

varied movement creates a “roller coaster” effect on vehicles driving through the site.

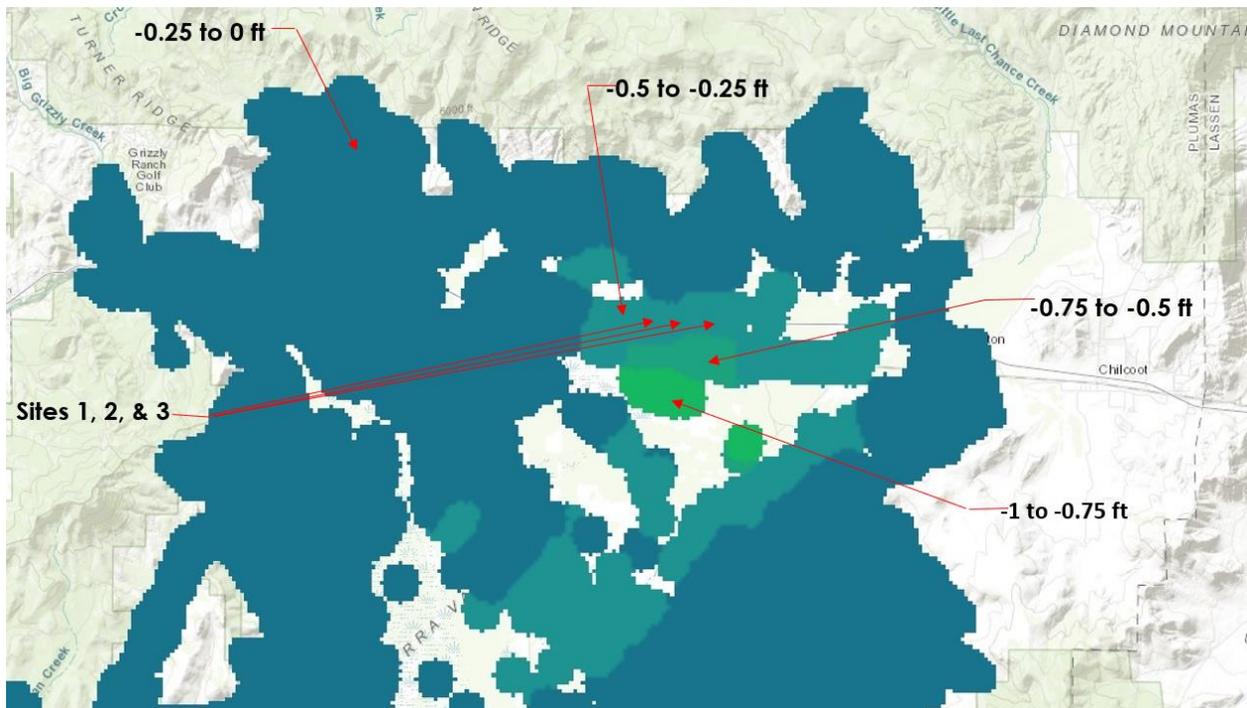
Figure 5 below presents a graphic from the online SMGA data viewer showing cumulative measured subsidence values for the Sierra Valley area from June 2015 to September 2019. The stretch of highway where sites 1, 2, and 3 are located is in an area that underwent 0.25 to 0.5 ft of subsidence during this period, according to the data in the SMGA data viewer.

Subsidence occurring in the Sierra Valley is considered to be a result of extensive groundwater pumping. When ground water is pumped and subsurface water levels drop, certain aquifers and aquitards become unable to support the existing void space within their sediments due to overburden pressure and they undergo permanent compaction, thereby reducing available void space for aquifer recharge. This is a phenomenon that has been well documented in many parts of the world, including the United States and California. Such over-pumping of groundwater has caused over 28 ft of subsidence in parts of the San Joaquin Valley of California (USGS, NASA). Besides reducing the storage capacity of aquifers, this subsidence can negatively impact buildings and infrastructure.

Figure 5. Map from SGMA data viewer showing total measured subsidence from 6/2015 to 9/2019. The three subsidence sites on SR70 are located within the region of -0.5 to -0.25 ft subsidence. Subsidence amounts (negative numbers) for the three different color-coded areas are indicated.

Due to a lack of any evidence linking the roadway pavement fractures to tectonic or surficial water processes, coupled with the documented evidence of ongoing subsidence occurring in the Sierra Valley, OGDN believes that it is highly probable that the fractures developed in SR70 east of Beckwourth are the result of this subsidence.

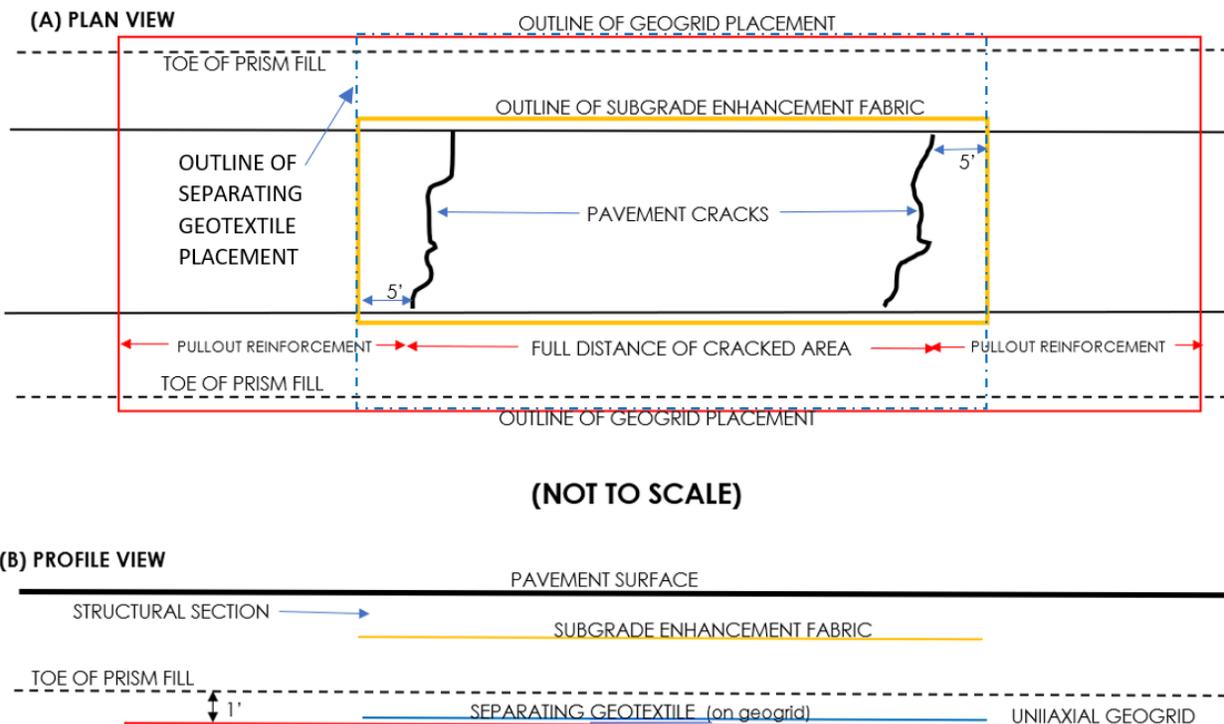
**Figure 6. (A) Plan View (top) and (B) Profile View (bottom)** of subsidence/cracking long-term mitigation design. The plan view outline of the geogrid placement is shown in red. The plan view outline of the separating fabric is shown with a blue dashed line. The plan view outline of the subgrade enhancement fabric is shown in orange. See text for more details.

Long term mitigation can be attempted during the Beckwourth Cap M project by excavating down to 1 foot below the bottom of the existing roadway prism embankment, installing geogrid together with a separating fabric at this base level, and then installing an additional subgrade enhancement geotextile at the bottom of the structural section. Figure 6 below provides both a plan view and profile view of this mitigation design.

The base uniaxial geogrid should be placed as a series of intact, spliced strips with the strength direction (machine direction) running parallel to the roadway direction. The minimum lengths of these strips should be uniform within each site and should equal the full distance of the cracked area as shown above plus an additional pullout reinforcement distance of 30 ft on both the east and west ends. This means, for example, that the minimum uniaxial geogrid strip lengths for Site 1 will be equal to 59 ft plus 2 times 30 ft, which equals 119 ft. Adjacent geogrid strips should not be overlapped but should be butted against each other. Geogrid coverage to the north and south shall extend at least 2 feet beyond the toe of the roadway prism embankment.

A separating geotextile is placed directly atop the geogrid. Geotextile strips should also run parallel to the roadway direction, with adjacent strips overlapped by at least 2 ft. Geotextile overlaps should be placed so that they are at least three feet away from the butted geogrid strip edges below. The lengths of the geotextile strips are to extend a minimum of 5 ft beyond the limit of cracking as shown in Figure 6 above. The extent of the separating geotextile coverage to the north and south shall be similar to the underlying geogrid, extending at least 2 feet beyond the toe of the roadway prism embankment.

The uniaxial geogrid should be pulled taught from both ends with a force of 2,000 pounds per 10-foot width of geogrid before being loaded with the first lift of soil. Nothing beyond manual tension is required for installing the overlying geotextile. Geogrid tension should not be released until at least 8 inches of compacted soil is in place atop the geogrid and geotextile.

Soil lifts should be compacted to a minimum of 95% relative compaction up to the bottom of the structural section. At that elevation strips of biaxial subgrade reinforcement fabric should be placed under manual tension atop the compacted soil. These strips should run parallel to roadway direction and be similar in length to the separating geotextile below- i.e., with at least 5 ft extending beyond the limits of cracking. The edges of neighboring subgrade reinforcement fabric strips shall butt against each other. Subgrade reinforcement fabric coverage to the north and south shall extend at least 1 foot beyond the edge of pavement. The completion of reinforcement fabric installation is then followed by construction of the structural section and paved surface.
